Technical Report CHL-97-25  
August 1997

# **Model Study of the Confluence of San Juan Creek and Trabuco Creek, Orange County, California**

## **Hydraulic Model Investigation**

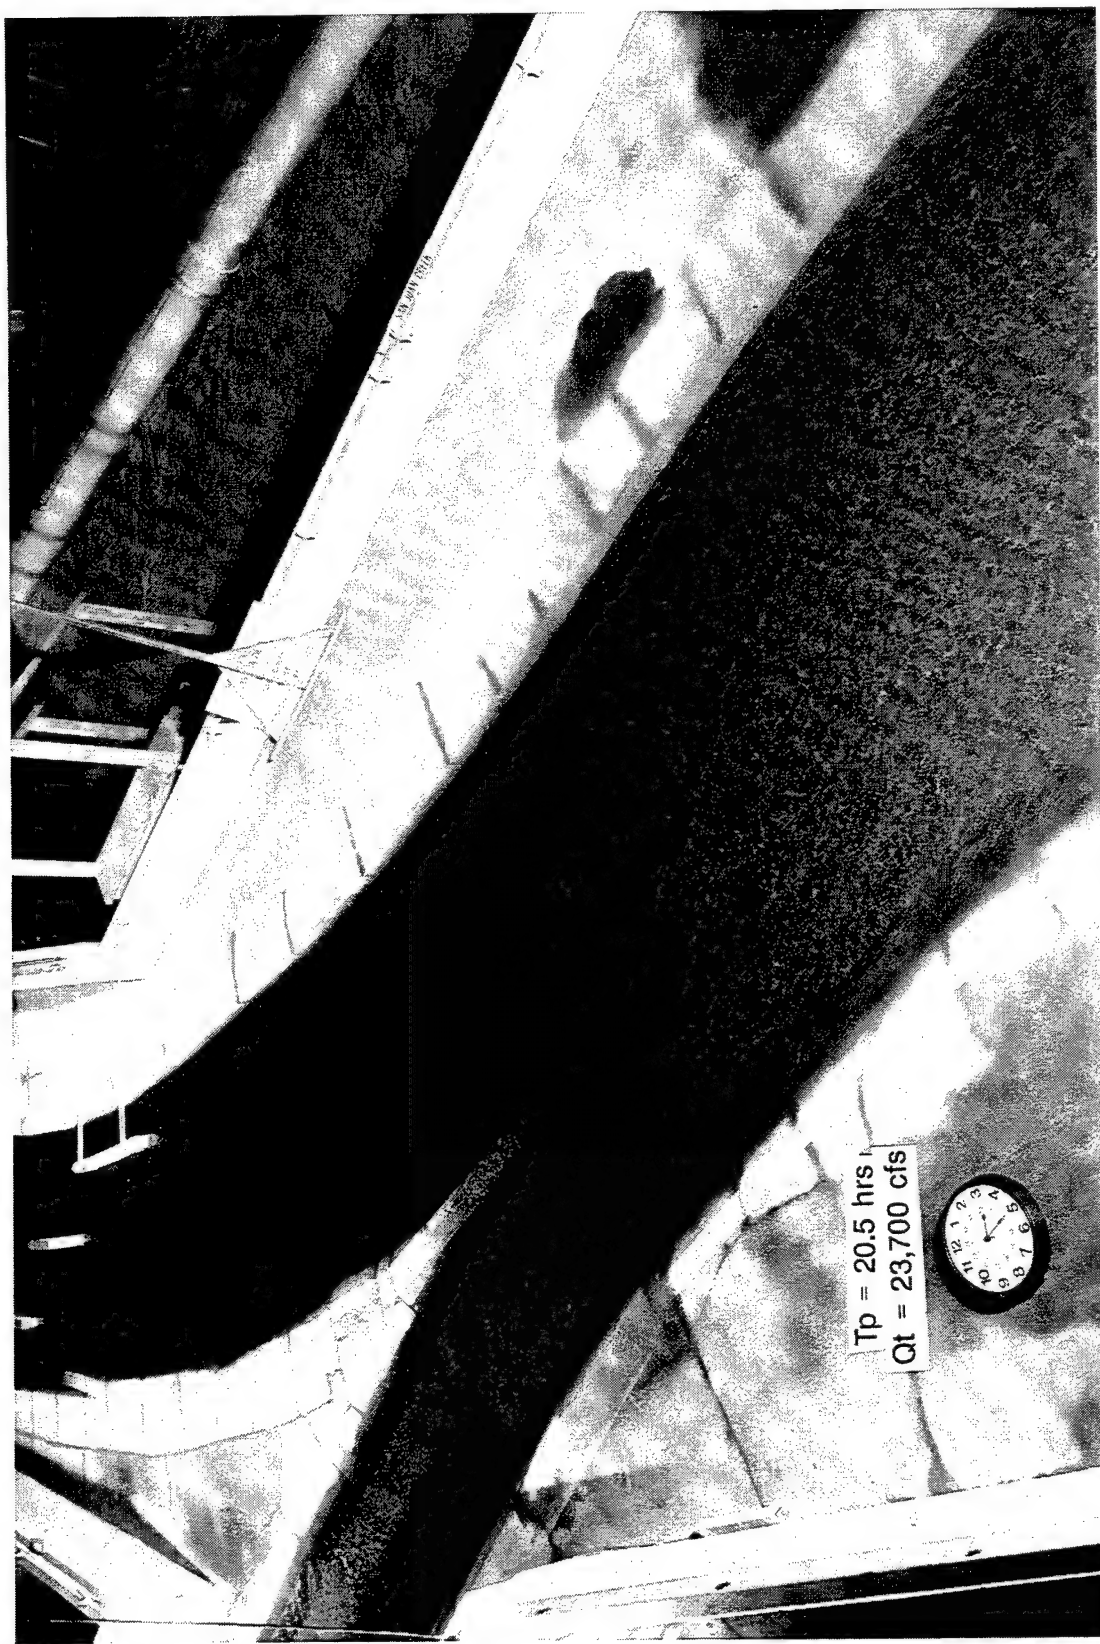
Photo 50.

San Juan Creek, type 7 design, flow conditions at confluence with Trabuco Creek during 24-hour storm hydrograph, looking upstream, prototype time 20.5 hours,  $Q_{sj}$  23,700 cfs (664 cu m/sec)

Before the gravel-bed experiment was run, the model was flooded from the upstream end. Once the model was completely saturated, the desired discharge was set. The discharges and duration of the 24-hr storm runoff hydrograph for both San Juan and Trabuco Creeks were simulated. The actual hydrographs and the simulated hydrographs for both creeks are provided in Plate 50. For the duration of the experiment, the flow remained uniform with occasional standing waves observed. The flow conditions observed around the railroad bridge piers in San Juan Creek at 1- and 2-hr intervals in the hydrograph are shown in Photos 14-33. Flow conditions observed at the confluence are shown in Photos 34-53.

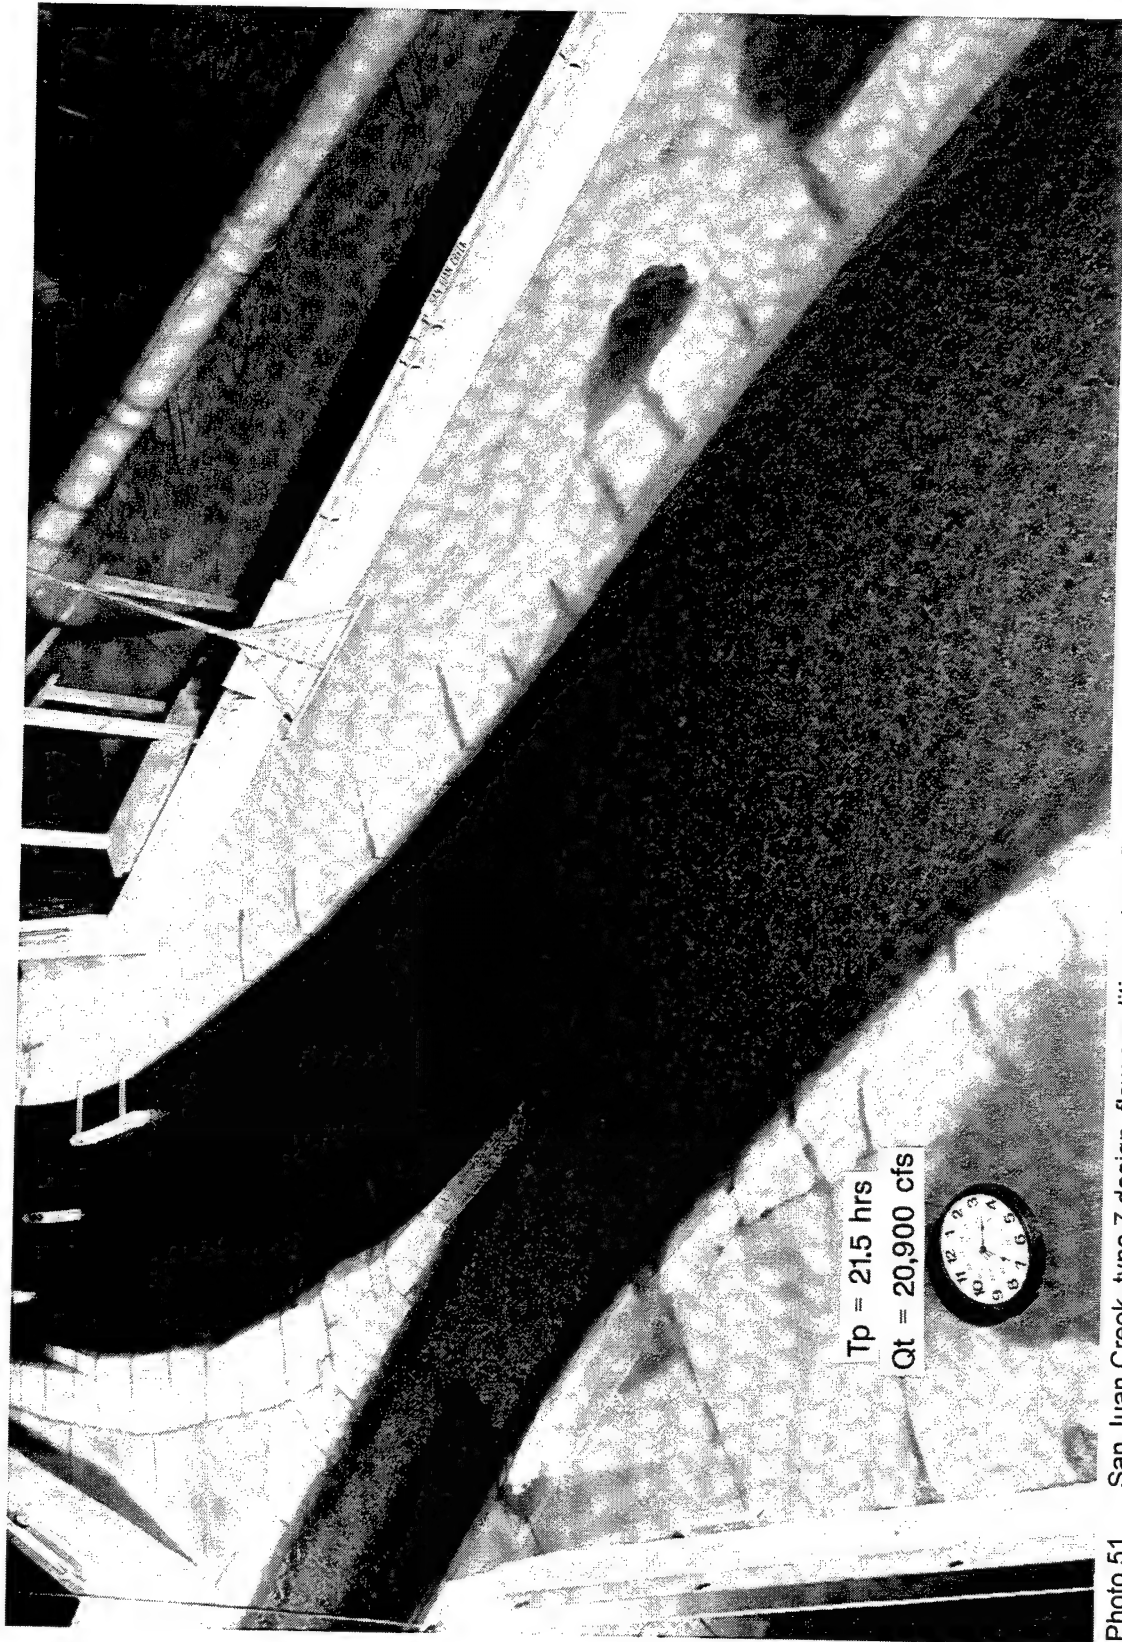
Photo 51.

San Juan Creek, type 7 design, flow conditions at confluence with Trabuco Creek during 24-hour storm hydrograph, looking upstream, prototype time 21.5 hours,  $Q_{sj}$  20,900 cfs (585 cu m/sec)

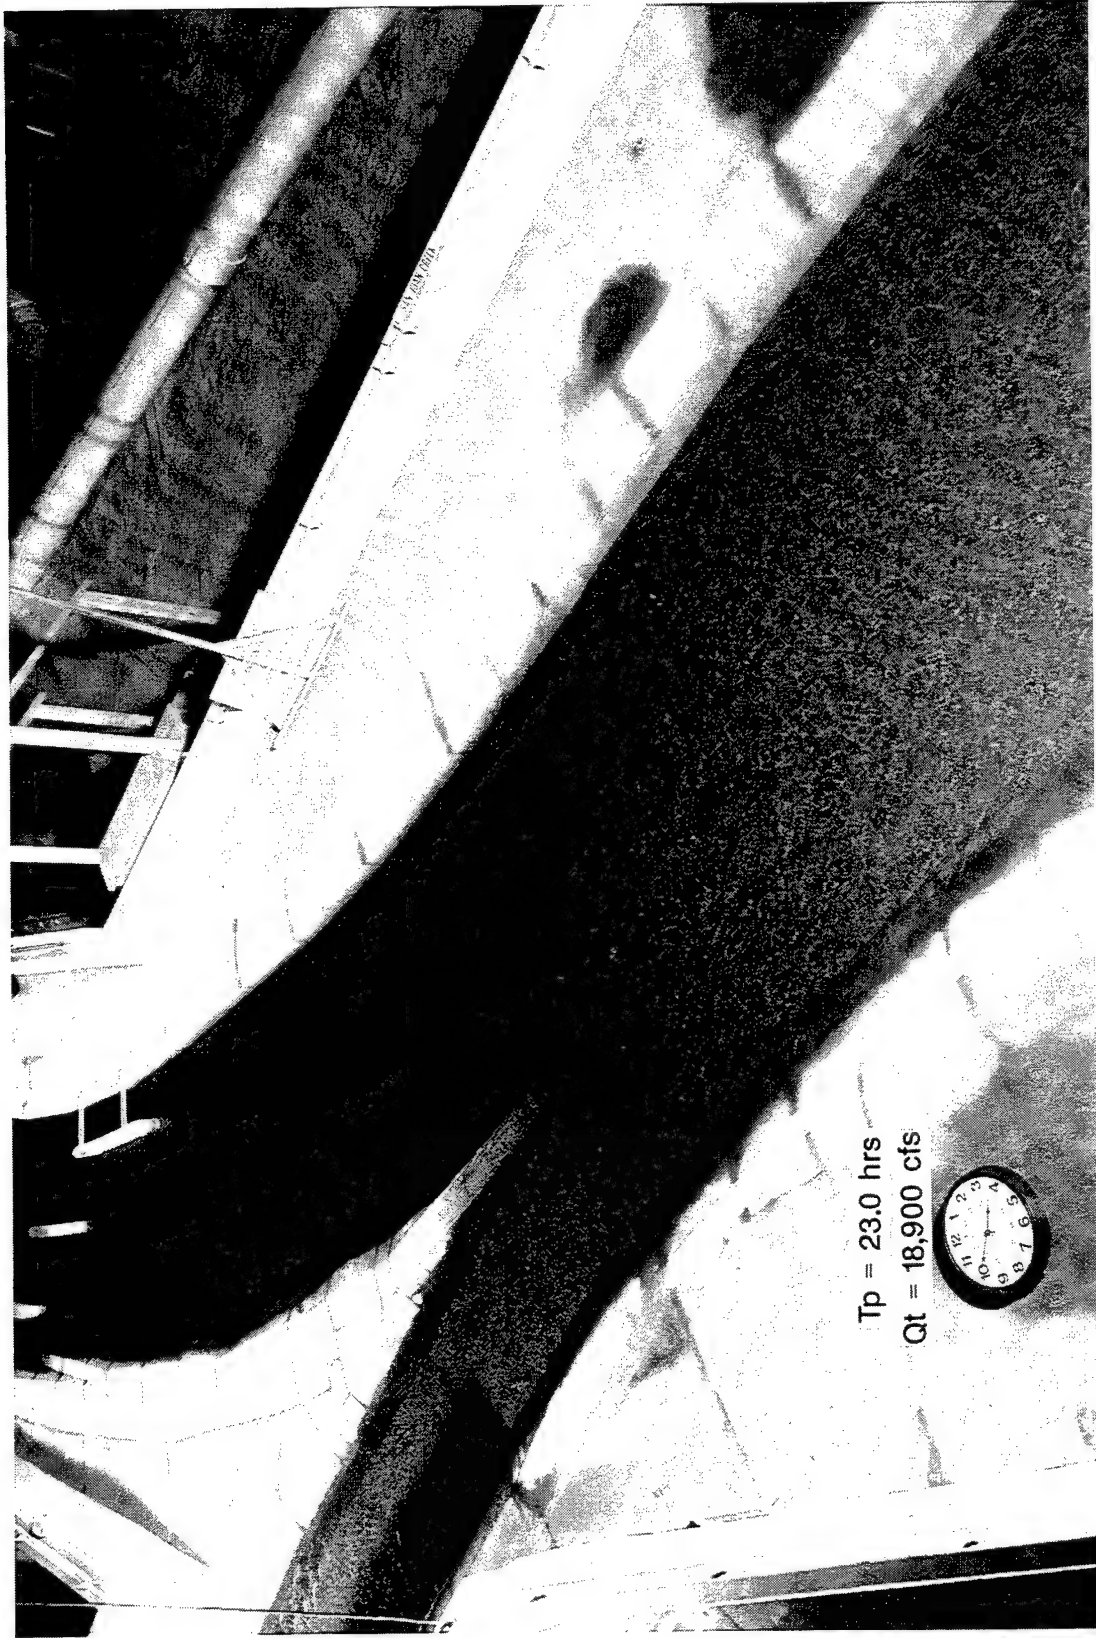
$T_p = 23.0$  hrs  
 $Q_t = 18,900$  cfs

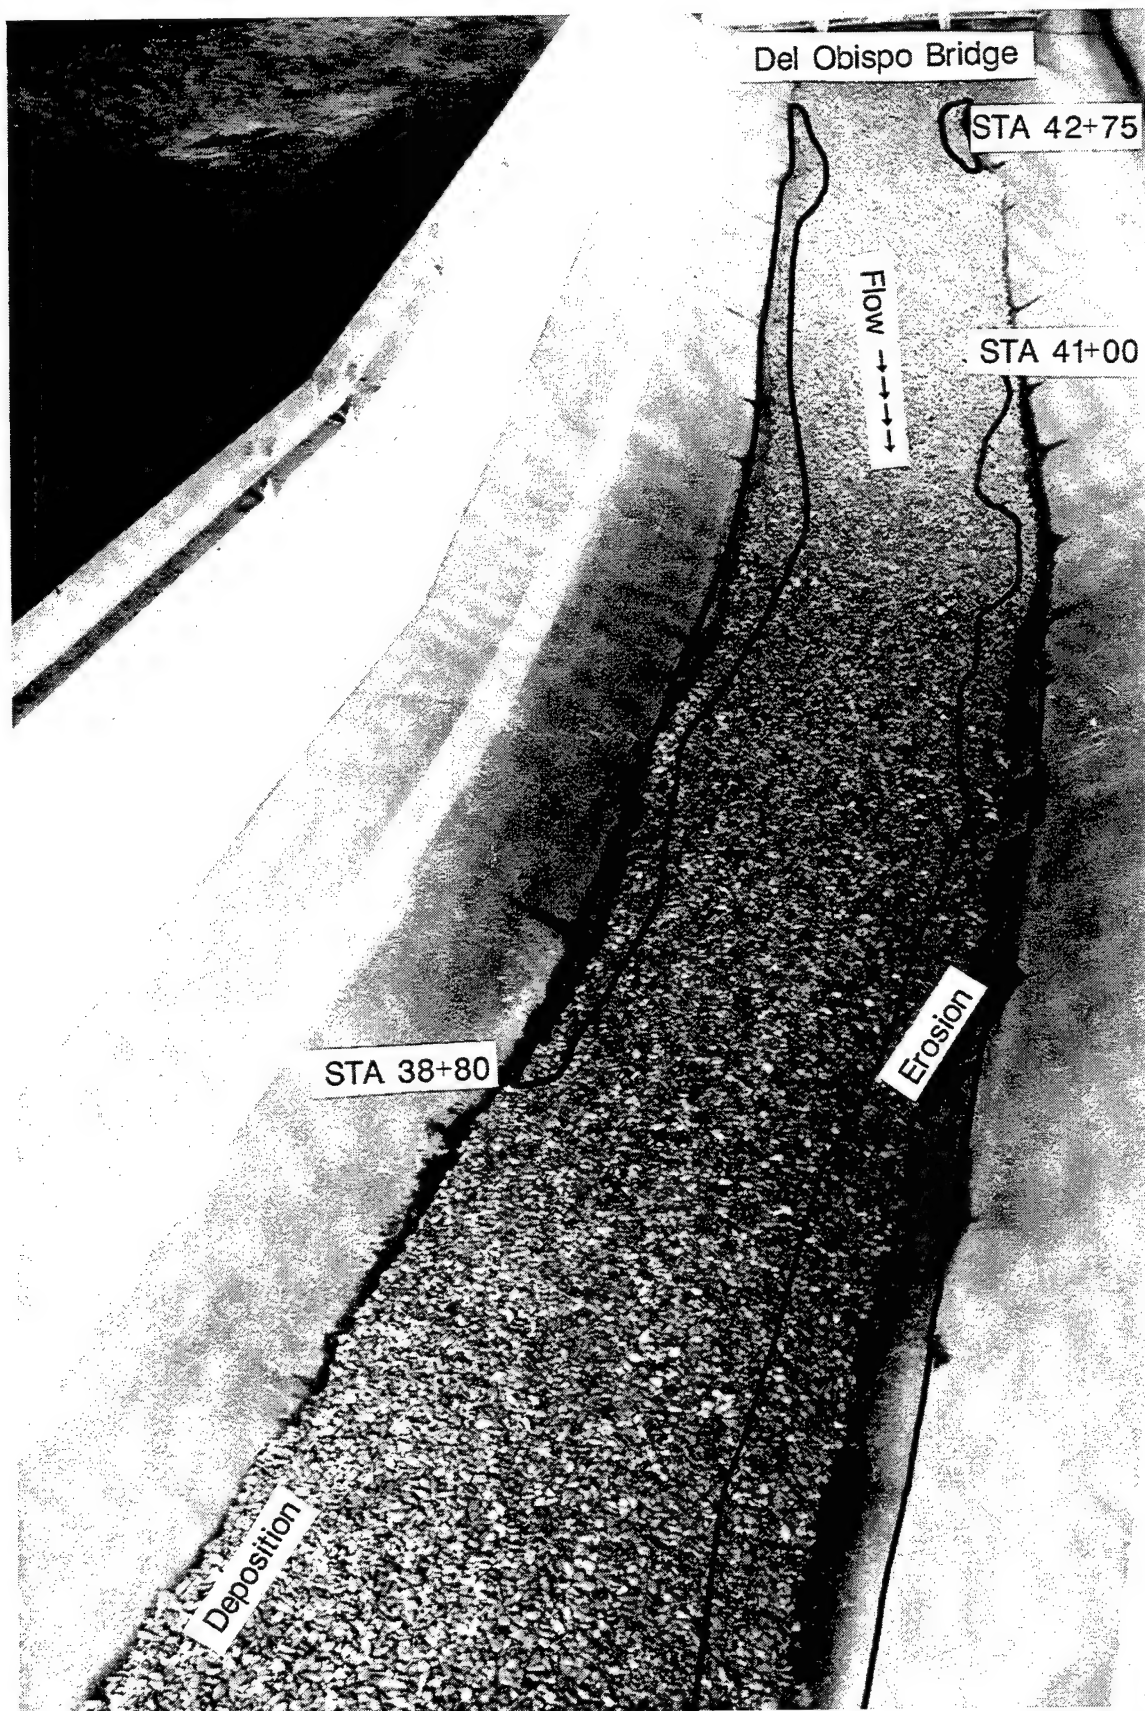
Photo 54. Trabuco Creek, type 7 design, 24-hour storm hydrograph, scour analysis test, gravel bed, potential scour areas around sta 38+80

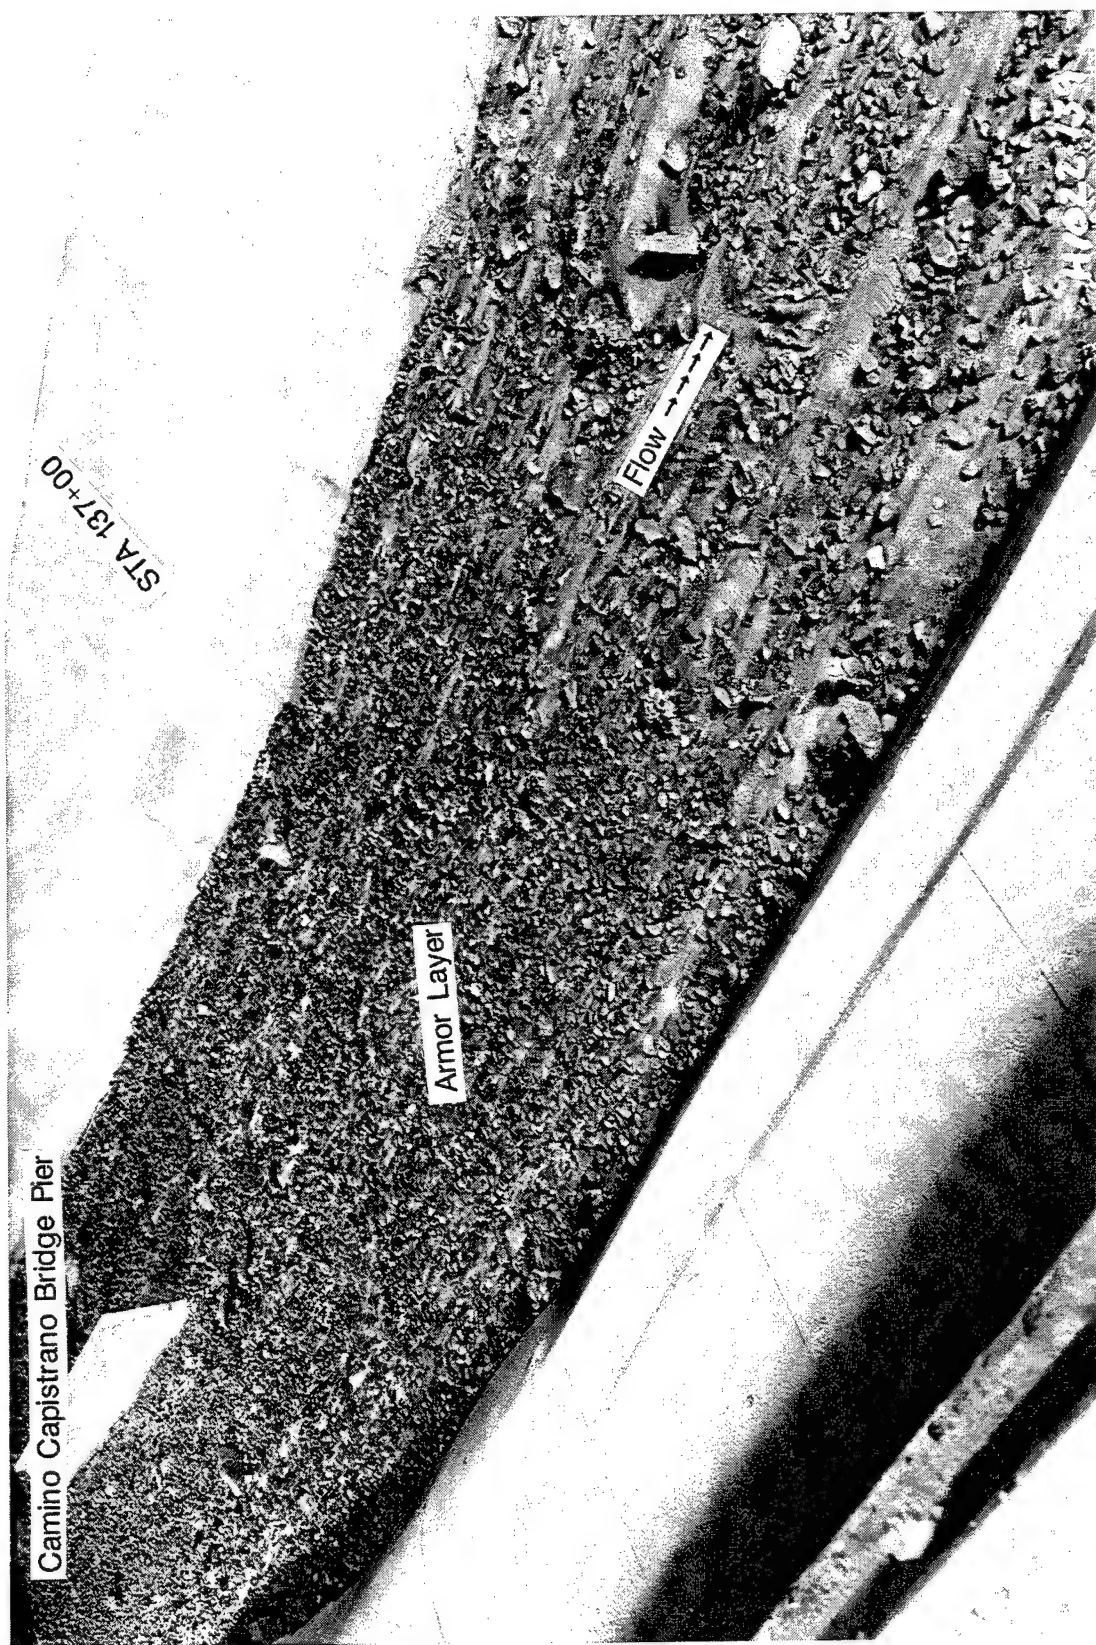
Photo 60. San Juan Creek, type 7 design, 50 percent peak, 24-hour duration, sand and gravel bed, armor layer, general degradation

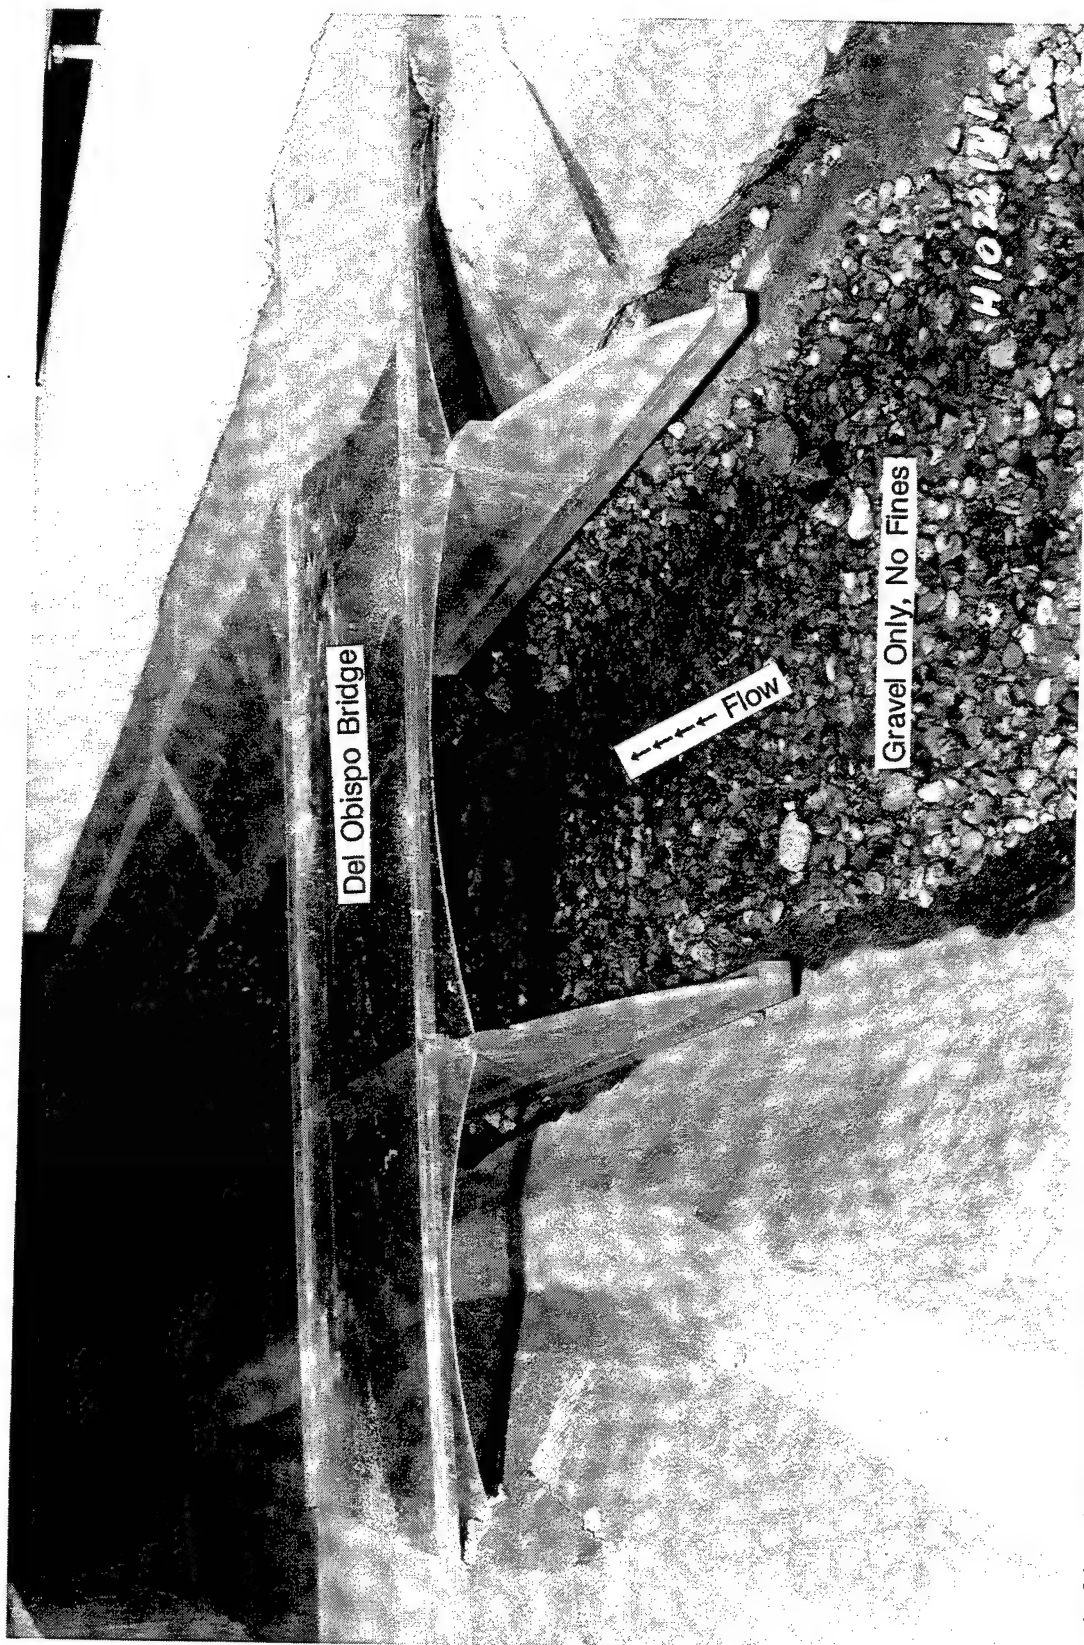
Photo 61. Trabuco Creek, type 7 design, 50 percent peak flow, 24-hour duration, Del Obispo Bridge, general degradation

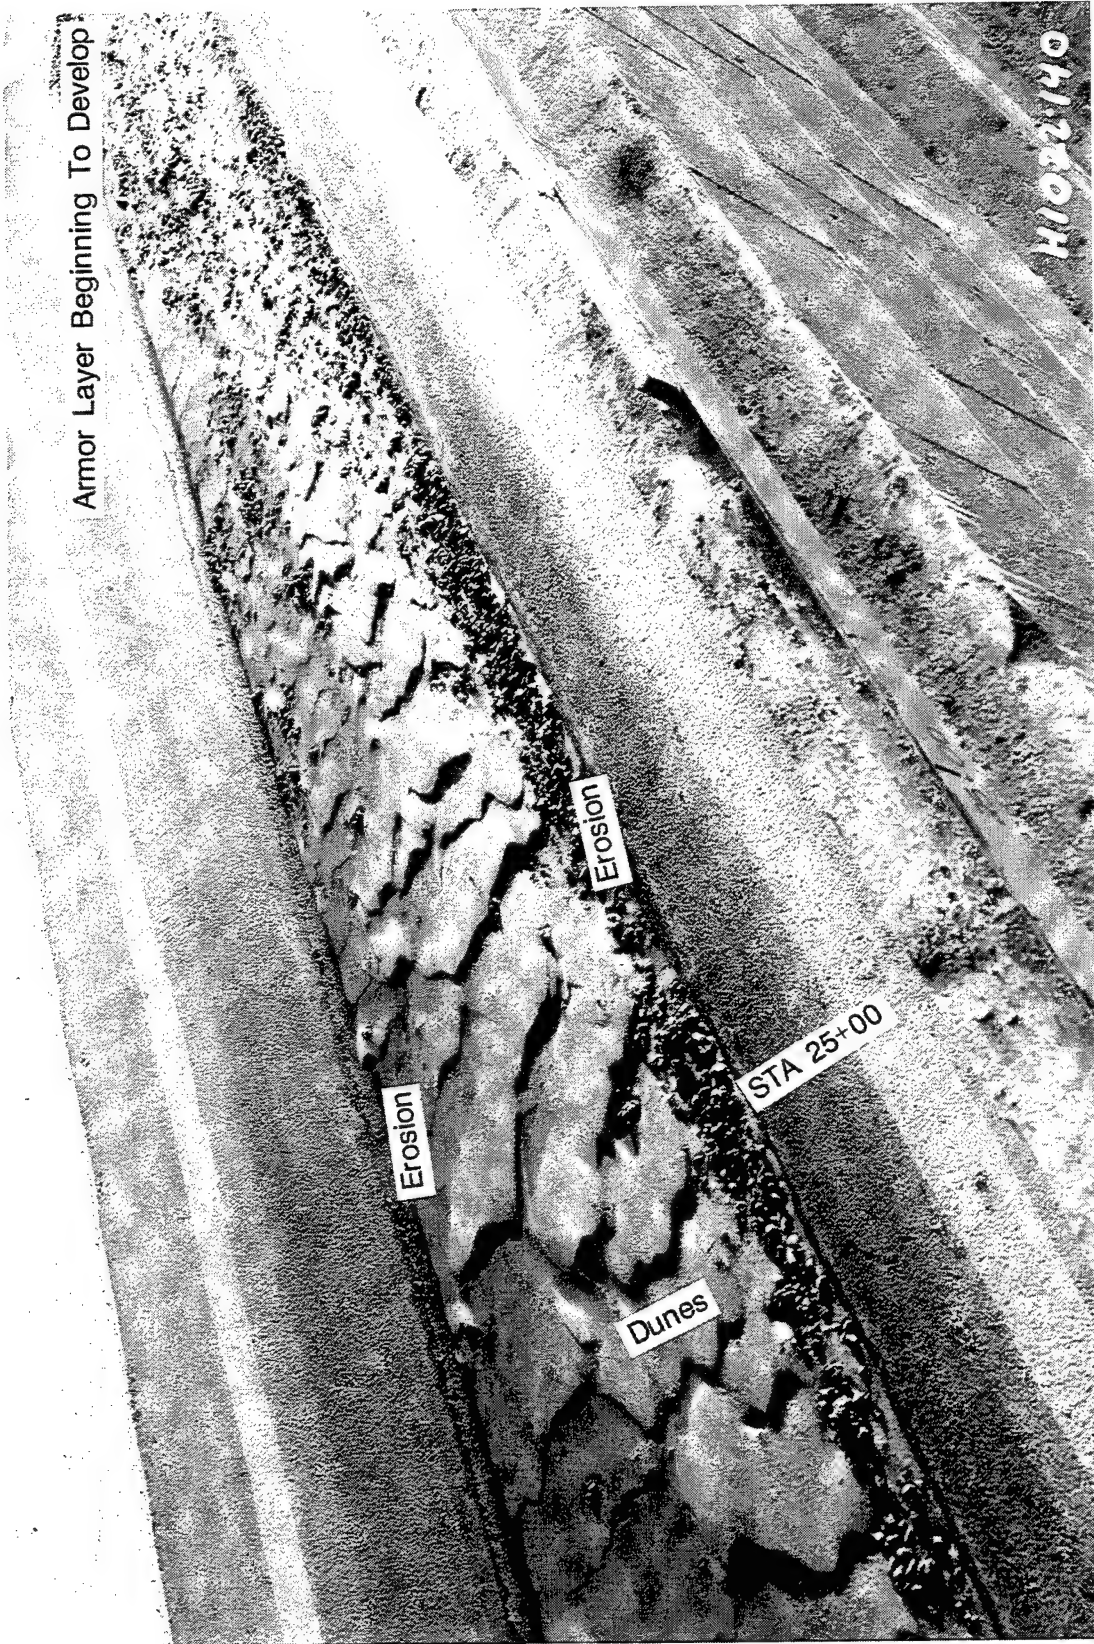
Photo 62. Trabuco Creek, type 7 design, 50 percent peak flow, 24-hour duration, scour analysis test, sand and gravel bed, dune beds with armoring
